**COMPREHENSIVE SITE ASSESSMENT  
PHASE II FIELD INVESTIGATION REPORT  
VOLUME I (Text and Appendix A through D)**

**Wilmington Facility  
Wilmington, MA**

**Olin Corporation**

**JUNE 1993**

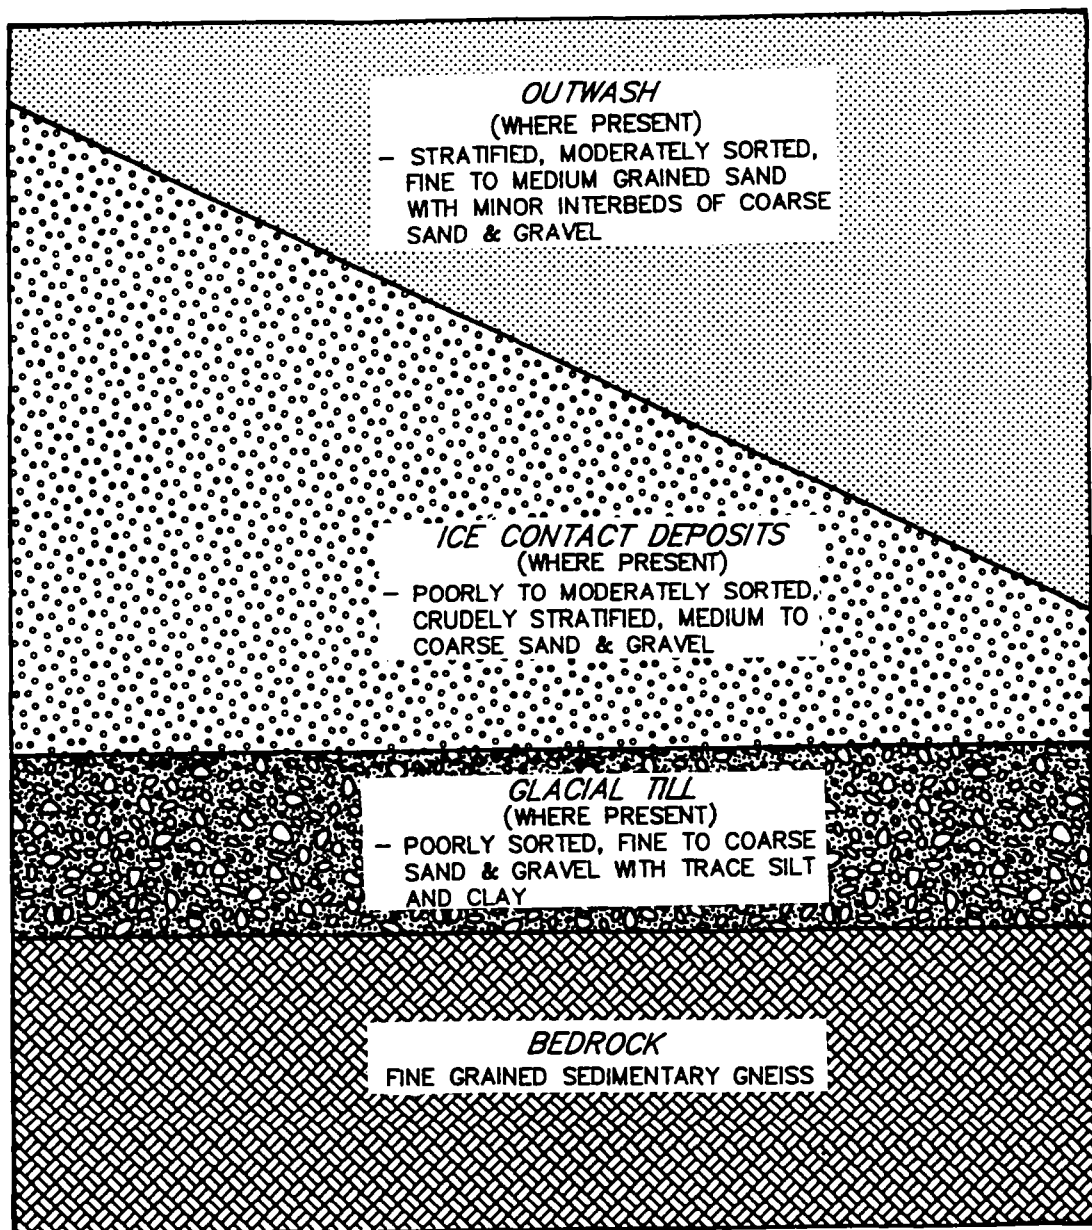
figure 3.1  
GENERALIZED STRATIGRAPHIC SECTION  
WILMINGTON FACILITY  
*Olin Corporation*

The CSA identified the following geologic units at the Facility, in descending order of age, as glacial outwash, glacial ice contact deposits; glacial till, and fine grained sedimentary gneiss. The glacial ice contact deposits and glacial outwash function as the single, principal hydrostratigraphic unit in the area of the Facility. The uppermost fractured portion of the bedrock is considered part of this flow system. Below the upper fractured bedrock, little groundwater is transmitted along small fractures and joints.

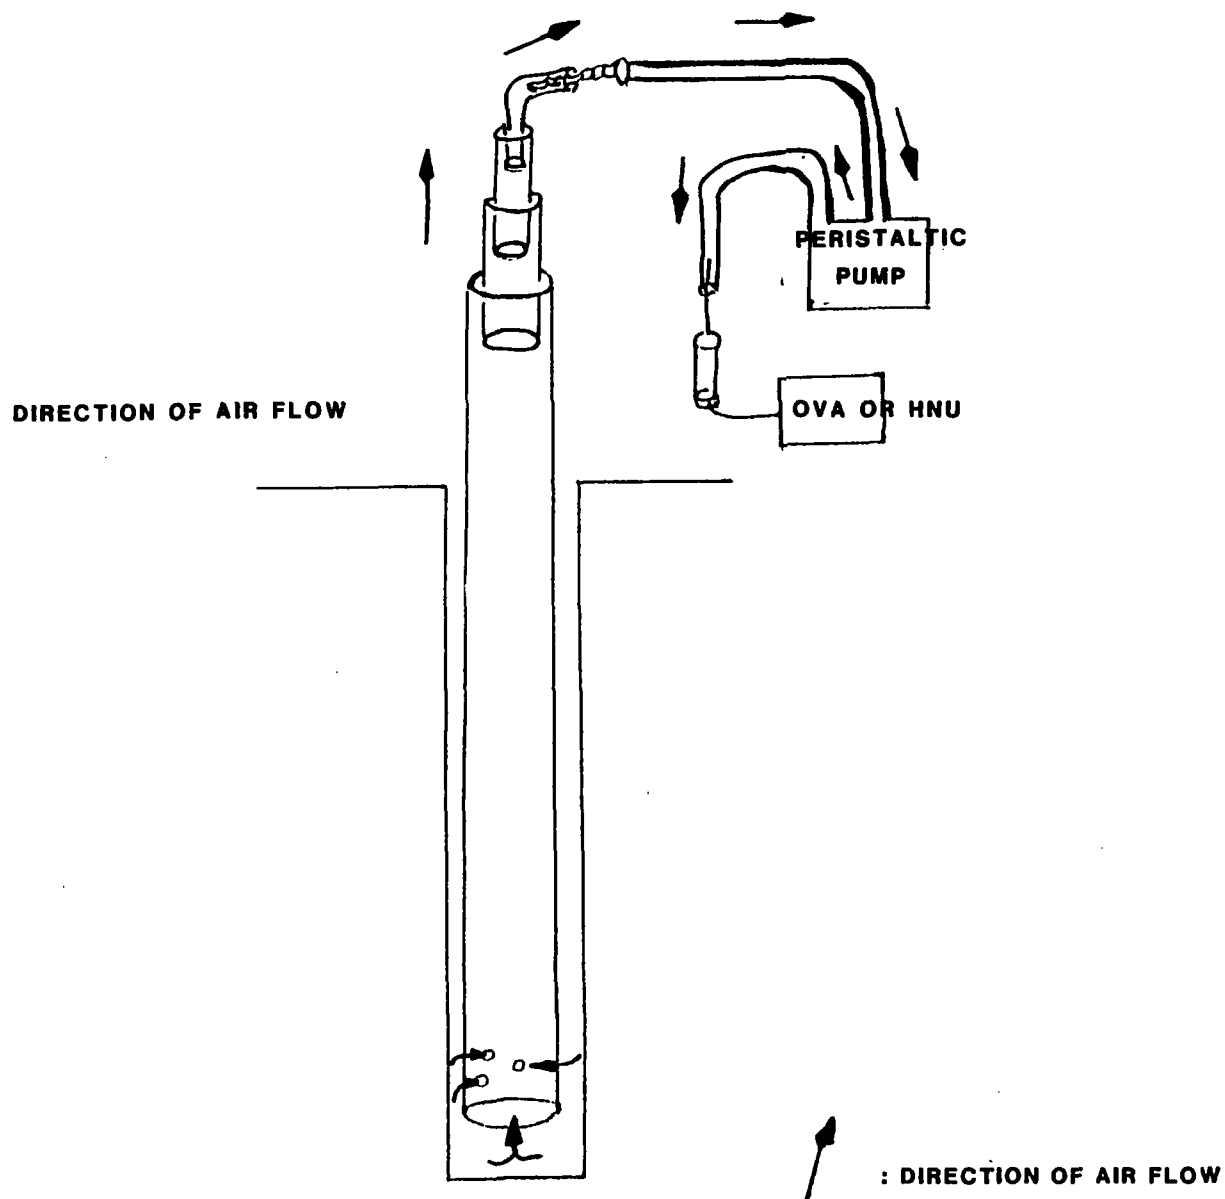
**FIGURE 2 : Soil Gas Sampling System**

LGI conducted a soil gas survey from February 5 through February 7, 1992. Fifteen (15) sample points (A series) were installed through the floor of the western warehouse, eighteen (18) sample points (B series) were installed through the floor of the eastern warehouse, ten (10) sample points (C series) were installed between the warehouse buildings, and seven (7) sample points (D series) were installed in the loading dock areas north of the buildings. Figure 3 provides the locations of the A, B, C, and D series sample ports. To monitor potential off-gases escaping from the penetrated warehouse subsurfaces, an explosimeter was utilized during borehole installations.

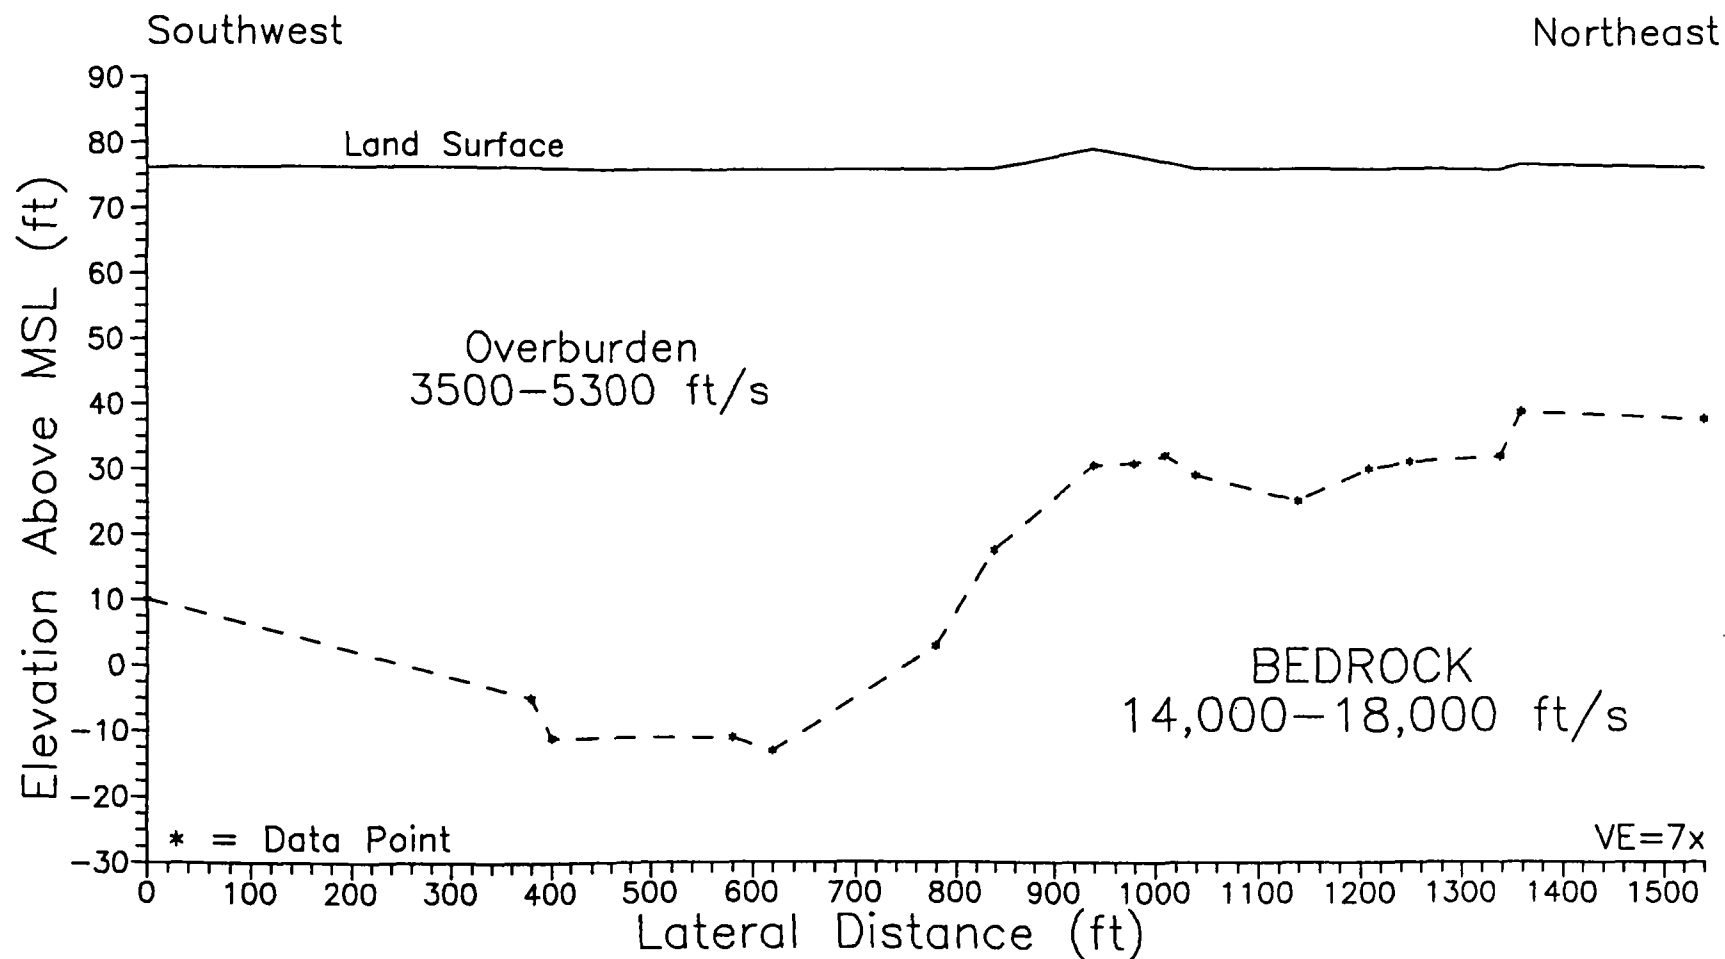
**FIGURE 3:**

Seismic Profile No. 1 (Study Area West of Olin Chemical,  
Wilmington, Mass.)

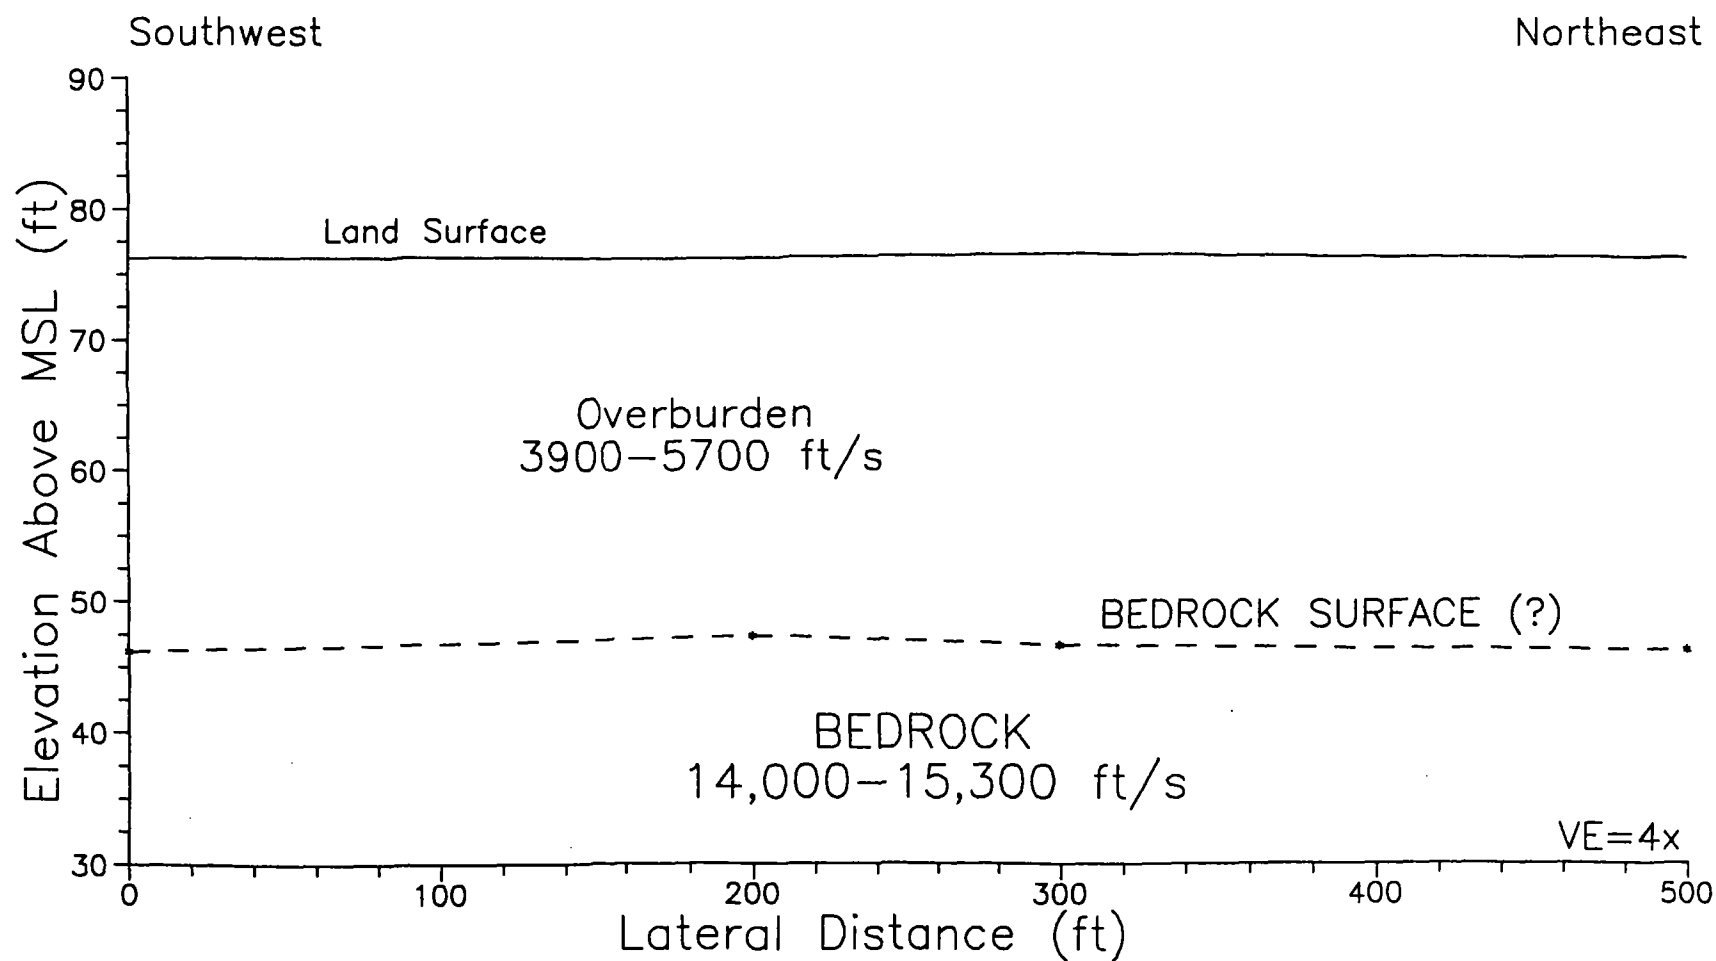
**FIGURE 4:**

Seismic Profile No. 2 (Wetlands Area West of Olin Chemical,  
Wilmington, Mass.)

A second seismic profile was positioned approximately 150 feet southeast of Profile No. 1 (see **Figure 4**). Data quality was poor along this traverse due to windy weather conditions. Interpretation is suspect for Profile No. 2. Velocity values appear consistent with the other profiles, but the depths to bedrock and morphology do not agree with the other traverses. The bedrock surface along Profile No. 2 appears flat-floored with a minimum of 30 feet of sediment overlying bedrock. Seismic reflection data interpretations were used for shot record 21R.

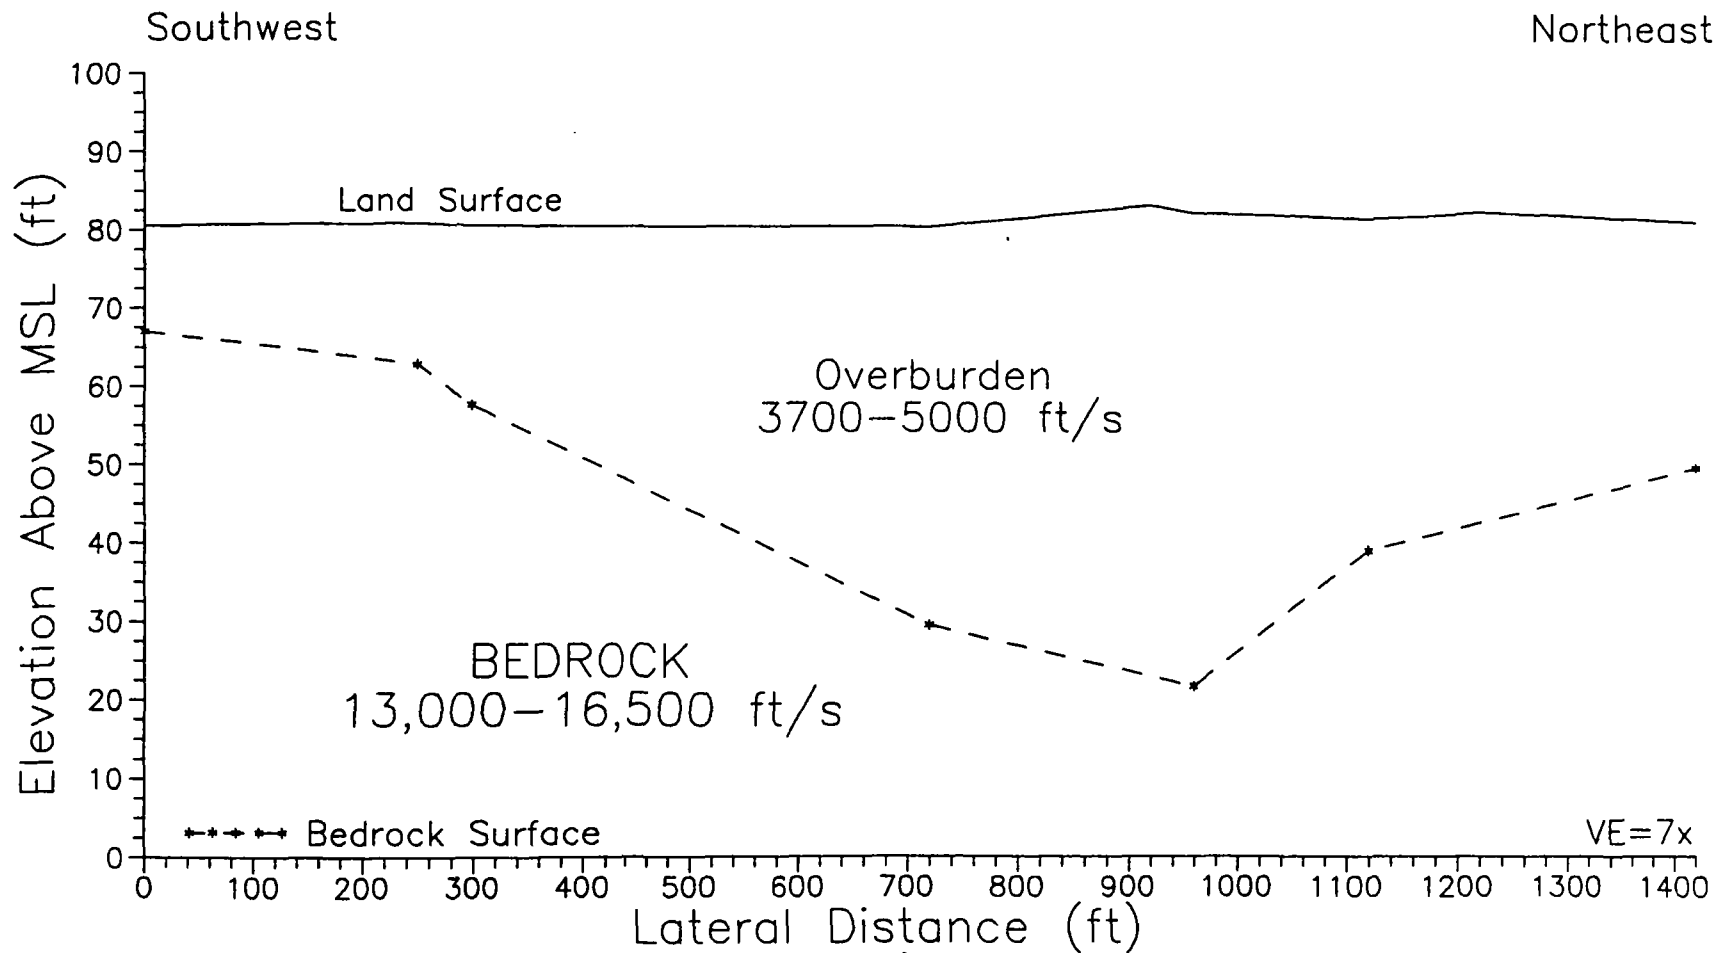
FIGURE 5:

Seismic Profile No. 3 (Study Area West of Olin Chemical,  
Wilmington, Mass.)

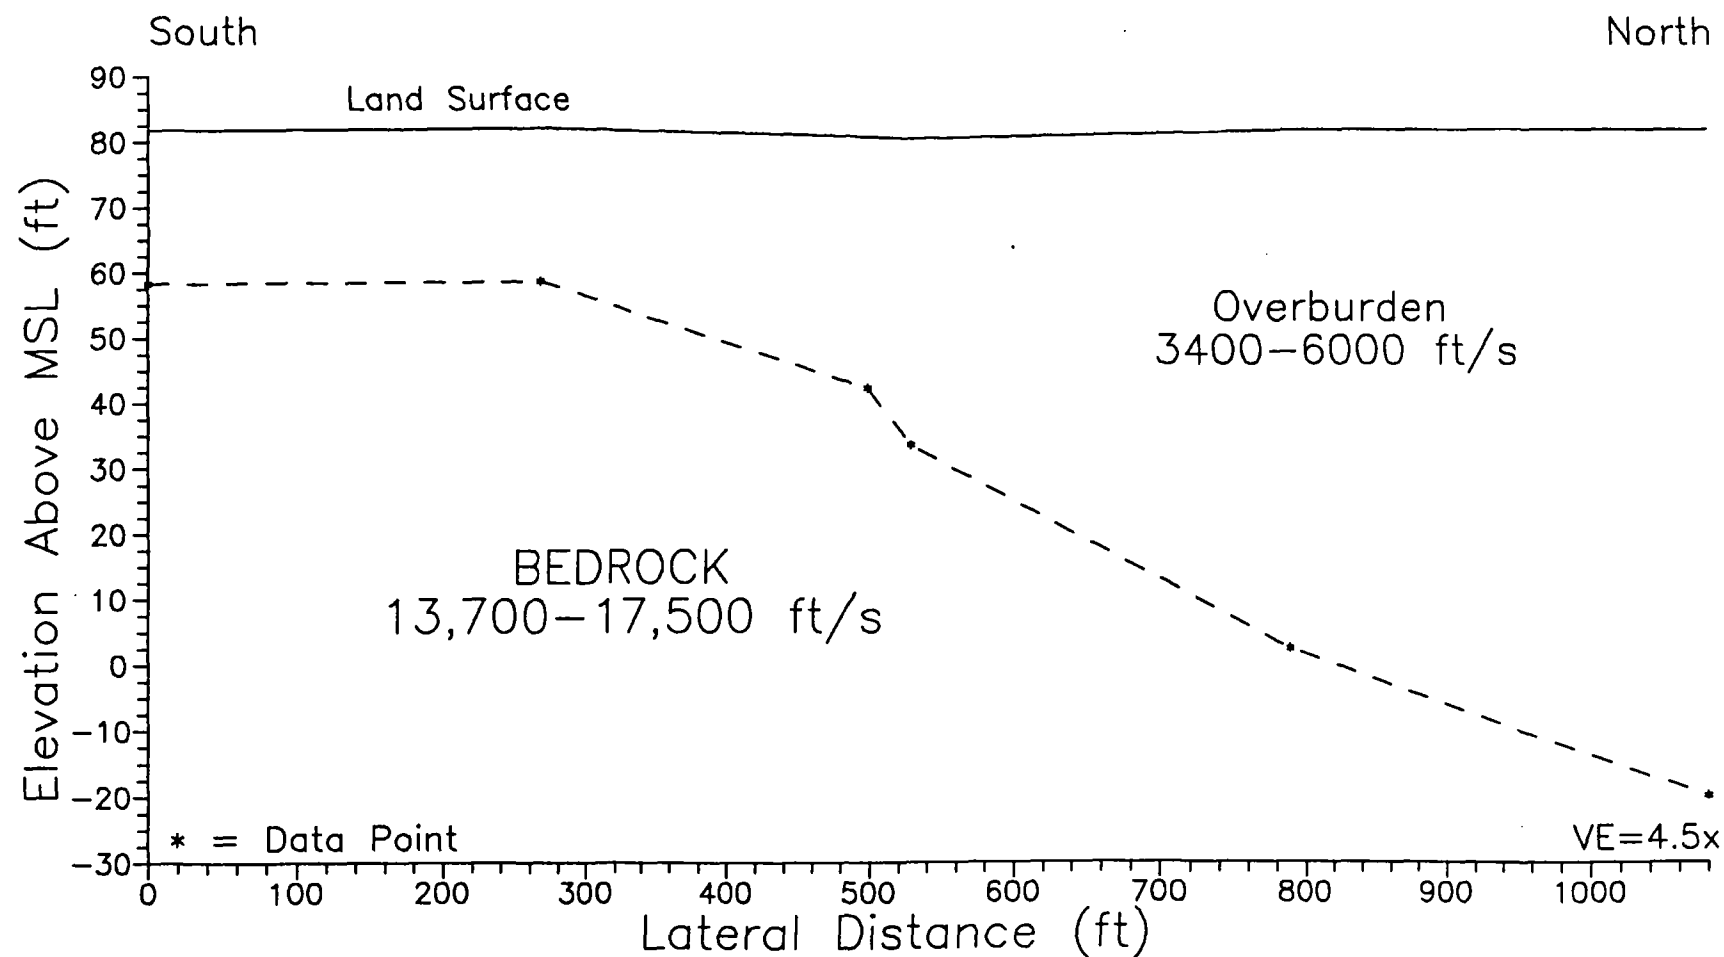
**FIGURE 6:**

Seismic Profile No. 4 (Study Area West of Olin Chemical,  
Wilmington, Mass.)

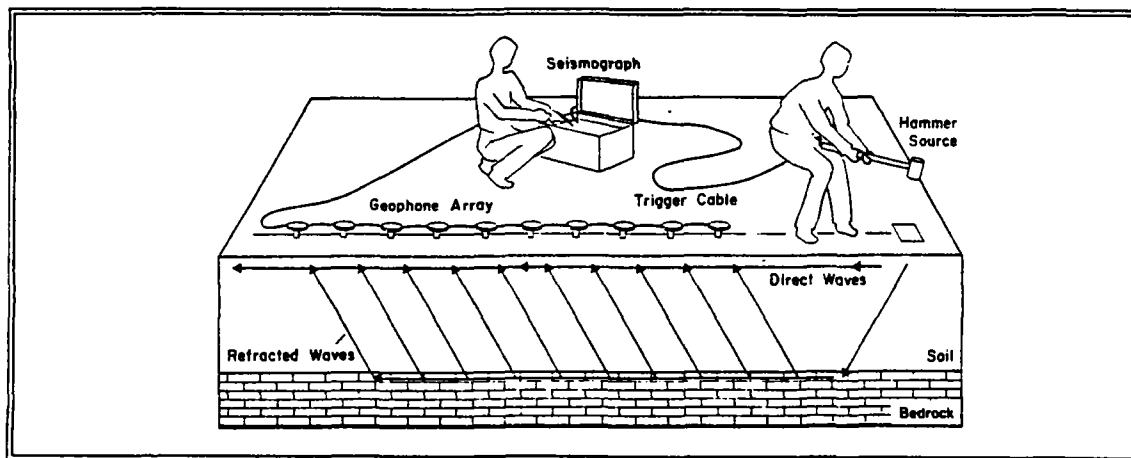
The seismic method involves the transmission of sound waves into the earth, and recording the earth's resulting response at set distances from the seismic energy "source"; this process constitutes one "seismic line". Each seismic line consists of twenty-four (24) receivers (geophones) which record the seismic energy (see **Figure 2**).

The seismic data is reduced and interpreted yielding a two-dimensional model of the subsurface. One two-dimensional model is derived from each seismic line. Because sound waves travel at different rates through dissimilar materials (i.e., faster through harder and denser materials), an insight to the relative hardness of subsurface materials can be discerned. Consequently, the seismic method furnishes information concerning the depth and relative strength or nature of subsurface materials.

Figure 2: Generalized seismic line diagram.

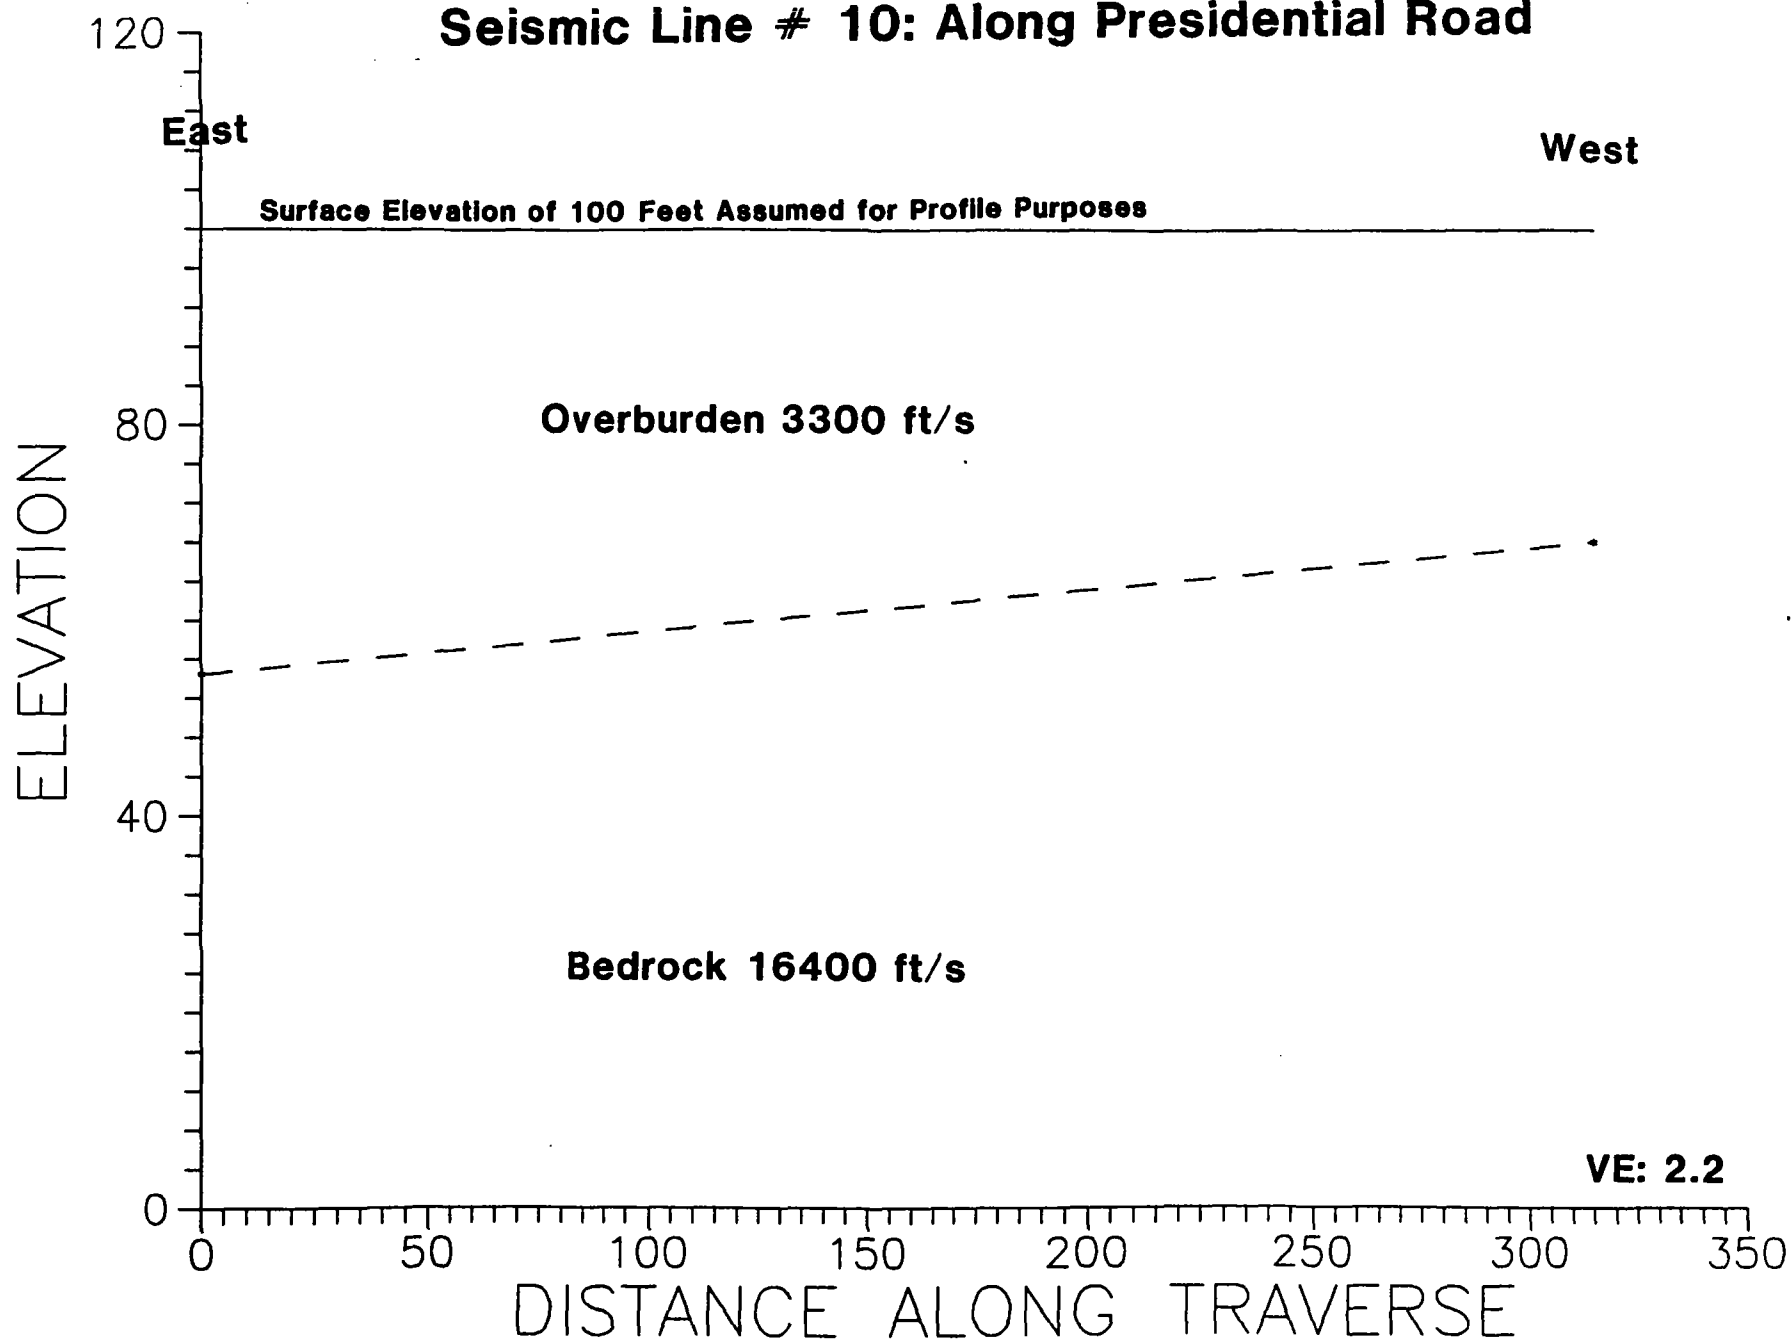
**SOLID LINES: Existing Topography**

**DASHED LINED: Bedrock Surface (unless noted otherwise)**

# Seismic Line # 10: Along Presidential Road

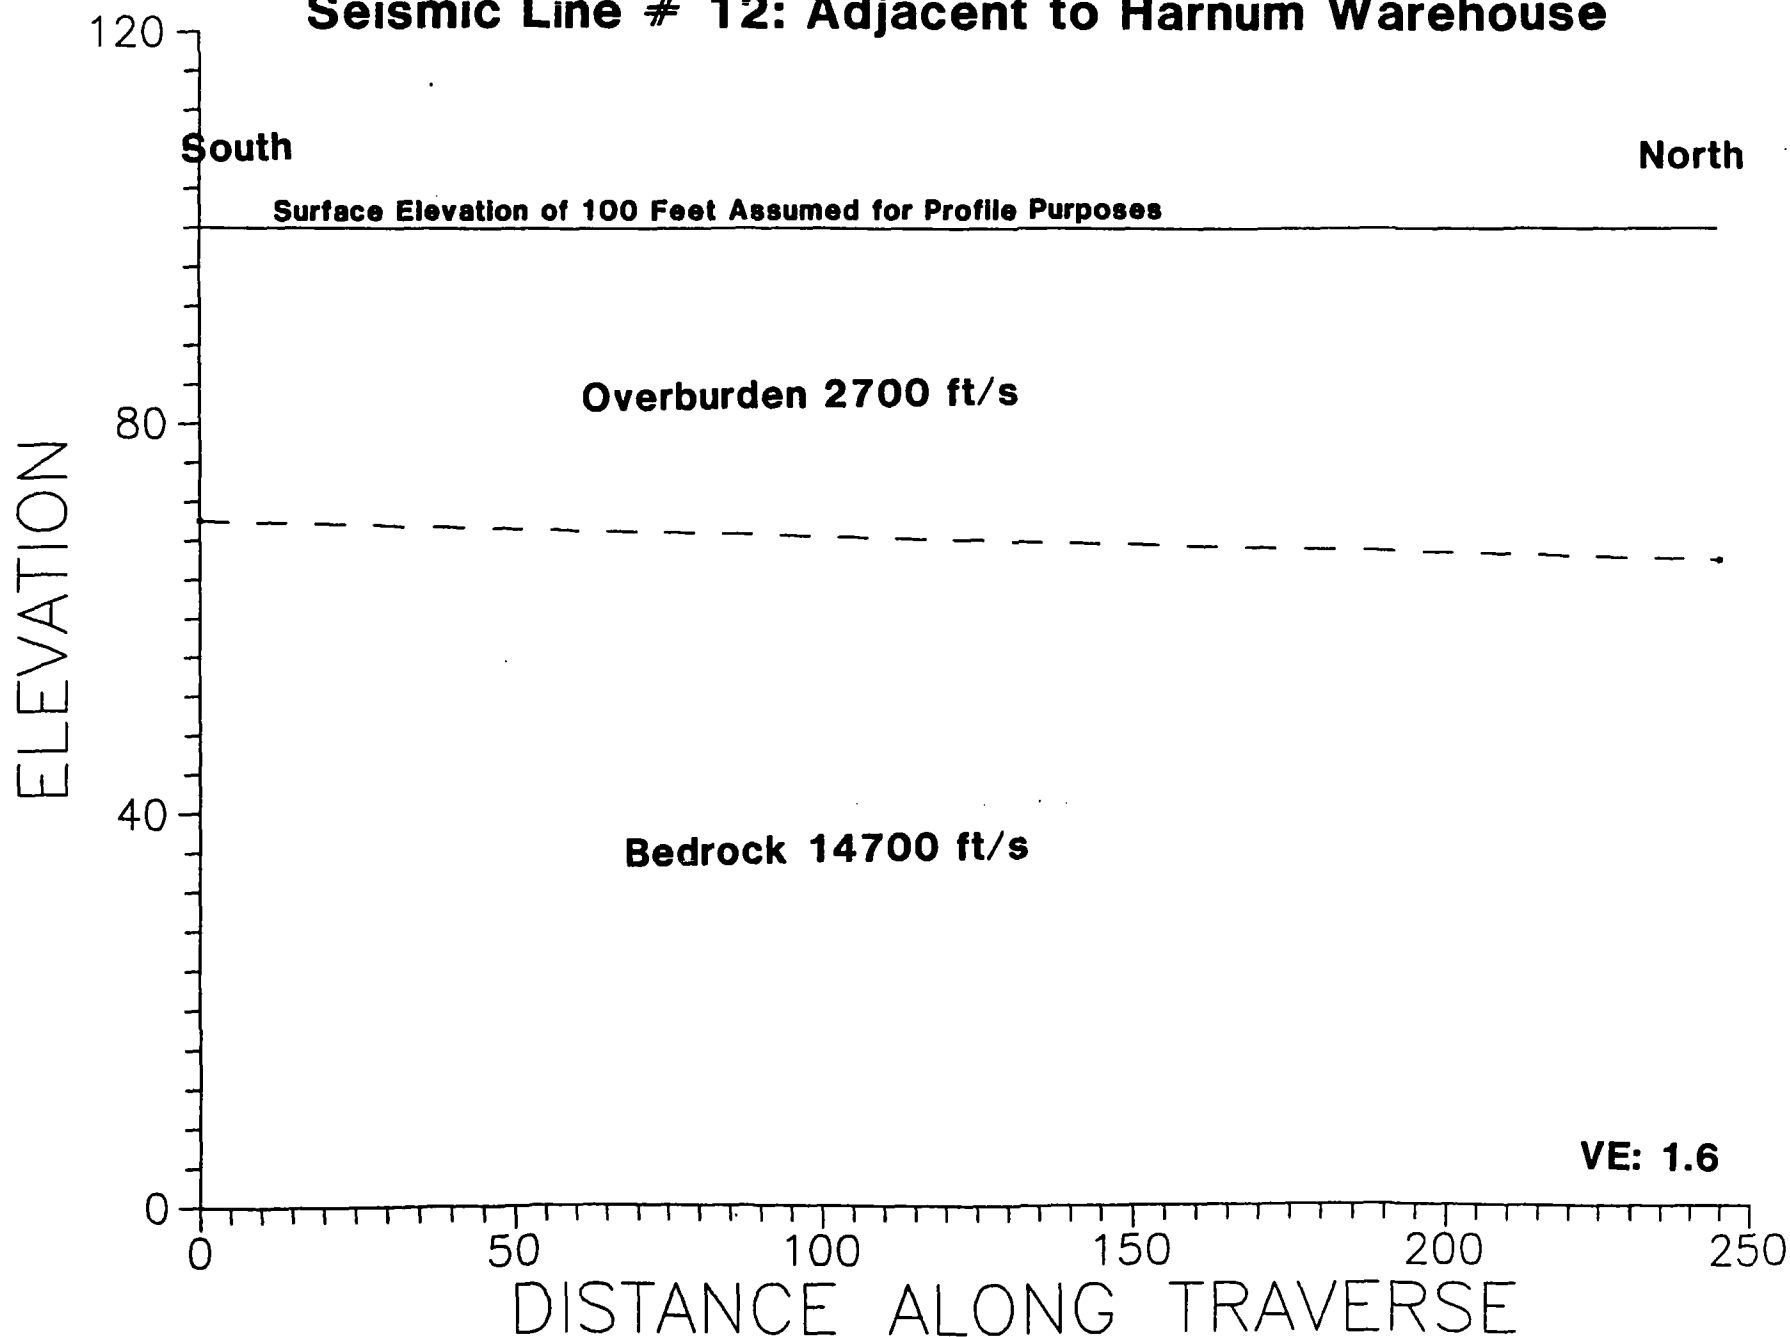
# Seismic Line # 12: Adjacent to Harnum Warehouse
